GPM Service and Repair leads the way to improved pump reliability in chlorine dioxide application.

Improving Axial Flow Pump Reliability in Paper Manufacturing

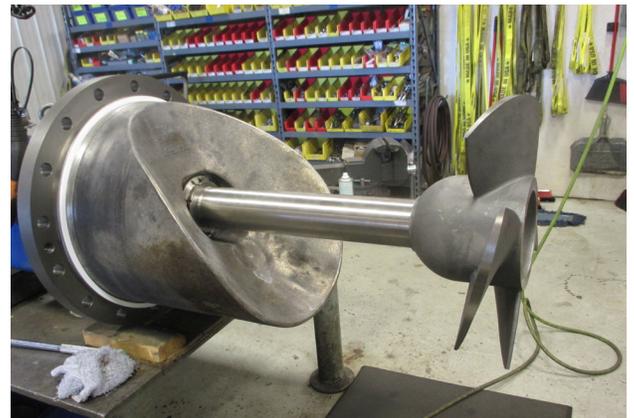
Figure 2: Axial Flow Pump Rotating Assembly

In this case, our customer's pump shafts kept breaking during normal, daily operations. Because continued service and repair on the same pumps is costly, the team needed to find a permanent solution.

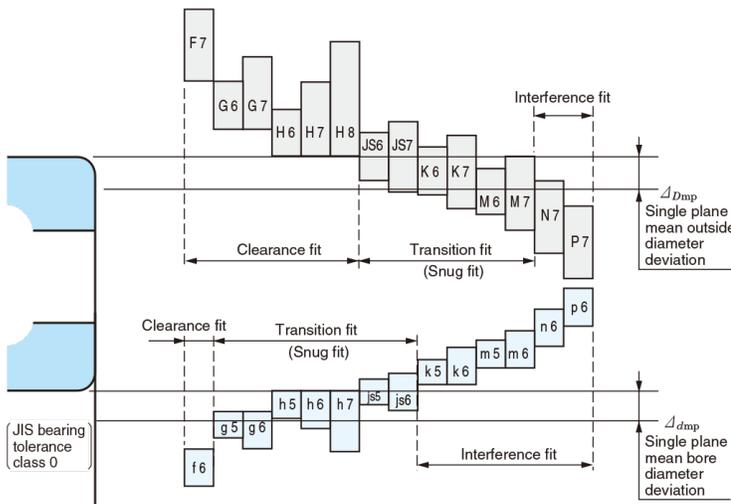
Figure 3: Tolerance & Fit for Shaft and Housing
Photo Courtesy of Koyo Bearings

The running clearances on an axial flow pump (or any pump) are critical. The tolerances between the propeller outside diameter (OD), elbow inside diameter (ID) and shaft total indicated runout (TIR) bearing fits, were all out of spec, so GPM also advised addressing these clearances as soon as possible.

Due to the complexity of renewing the clearance between the propeller and elbow, the GPM team started at the bearings on the other end of the shaft and worked their way out. The team increased the bearing journal shaft OD by 0.0009" to 0.0017", which increased bearing life significantly. This modification was also conducted on all three rotating assemblies. When the eventual new elbow was installed, this major change out also helped correct several additional factors, including the footing and base mounting of the pump within the system. Another critical clearance adjustment brought back the propeller running clearances to OEM spec, which helped reduce cavitation.

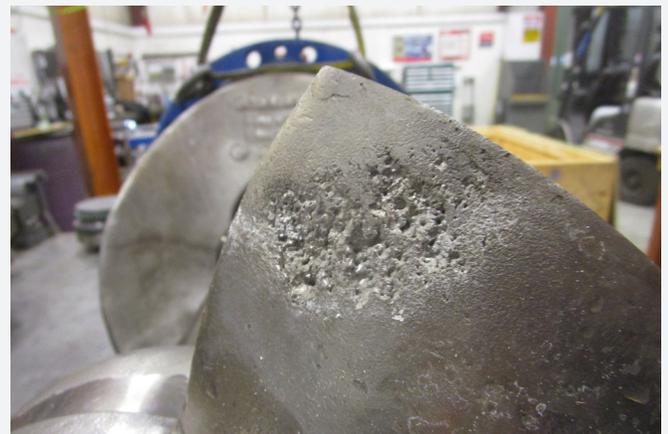
Figure 4: Propeller Cavitation Damage
