GPM Service and Repair leads the way to improved pump reliability in chlorine dioxide application.

Improving Axial Flow Pump Reliability in Paper Manufacturing

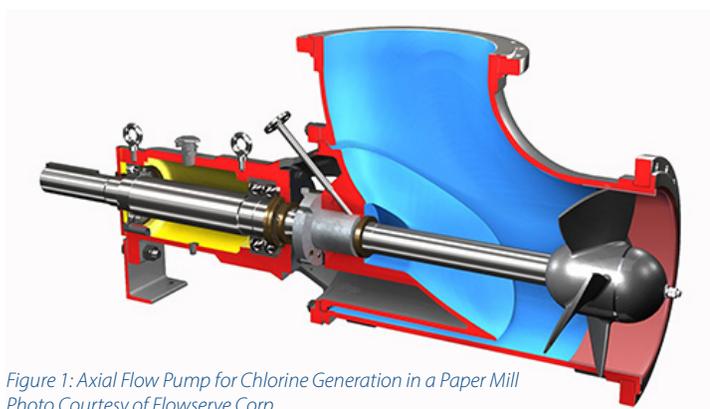
Figure 1: Axial Flow Pump for Chlorine Generation in a Paper Mill
Photo Courtesy of Flowserve Corp.

In this case, our customer's pump shafts kept breaking during normal, daily operations. Because continued service and repair on the same pumps is costly, the team needed to find a permanent solution.

Our first step was analyzing the situation. Because the customer was experiencing repeat issues, we suspected extenuating factors beyond traditional problems like a breach seal or bearings failure. We checked for common issues, including pump misalignment, uneven or warped baseplate/structure, and drastic changes in the flow through the pump, which can stress the pump shaft and cause deflection. In this case, we found that the customer's pump was subjected to added stress at the first point of stabilization, the mechanical seal.

Mechanical seals are designed to stop liquid from migrating into a motor or set of bearings. They can't withstand much shaft deflection, so when uneven loading is transmitted through to the bearings, seal failure is common. Pumps at the paper manufacturing plant were burning out fast.

Over the years, and due to the ramped-up urgency of completing repairs quickly, the customer was repairing the pumps with the most readily available parts, materials and resources. At the time, it was their only option, so the scope of repairs was understandable. GPM recognized how material changes for the customer and reworking components could lead to shorter turnaround times, but this also contributed to greater problems. GPM advised returning the pump to its OEM state, including the use of OEM specified parts. Getting back to OEM specs was the optimal path forward to increase the Mean Time Between Failures (MTBF).
